Thermal Imaging as a Forensic Tool in Coating Failure Investigations

E. Bud Senkowski, P.E., Senior Consultant, KTA-Tator, Inc.

CASE STUDY

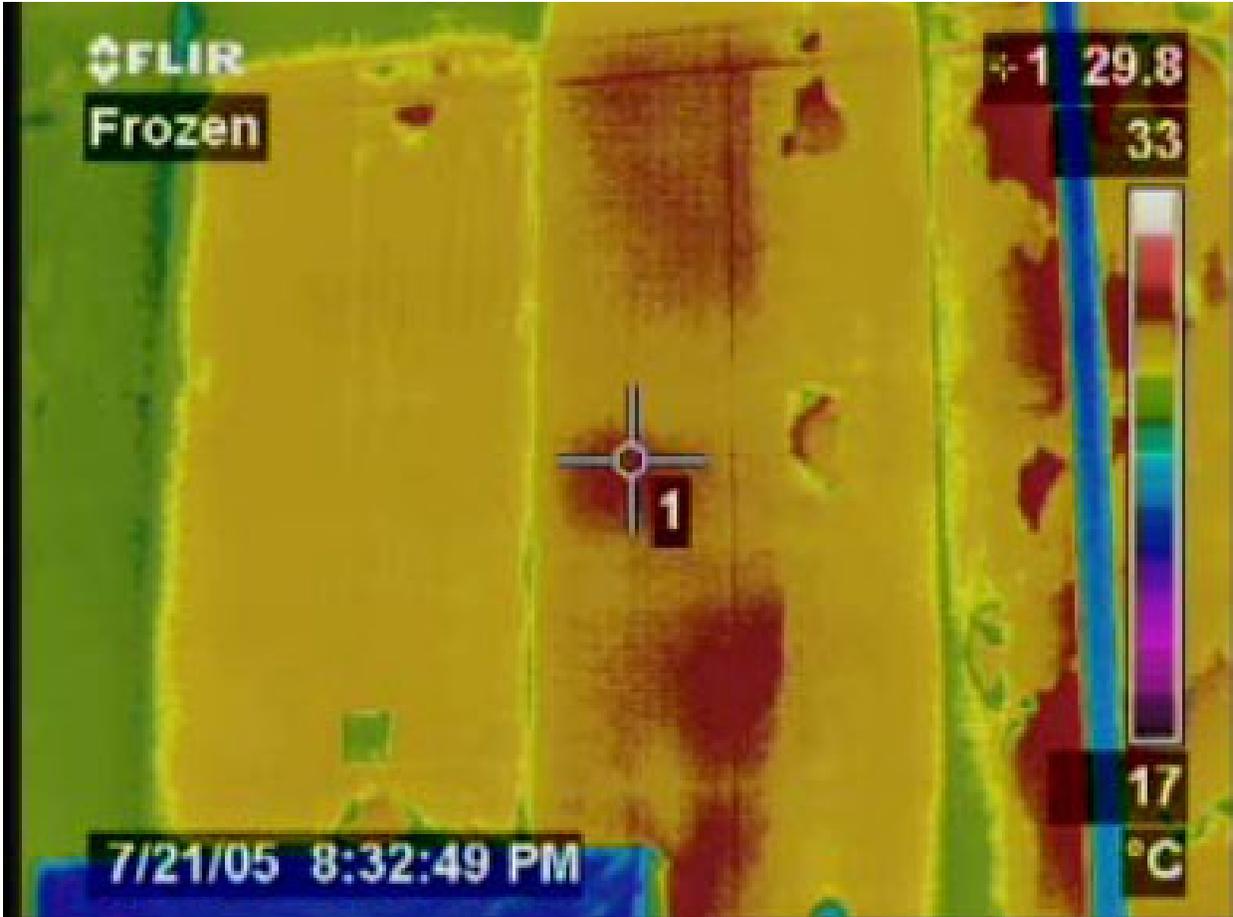
Figure 2

Figure 2, below is a thermogram for a sequence of three adjacent panels on the south wall of the building. The picture depicts three large yellowish-brown panel areas with elevated temperature. The two panels to the right also contain isolated red-brown areas that are at a higher temperature. The thermogram indicates that that the three-panel area exhibits temperature anomalies typical of moisture infiltration, with the color range of yellow-brown to red-brown attributed to increasing moisture content.

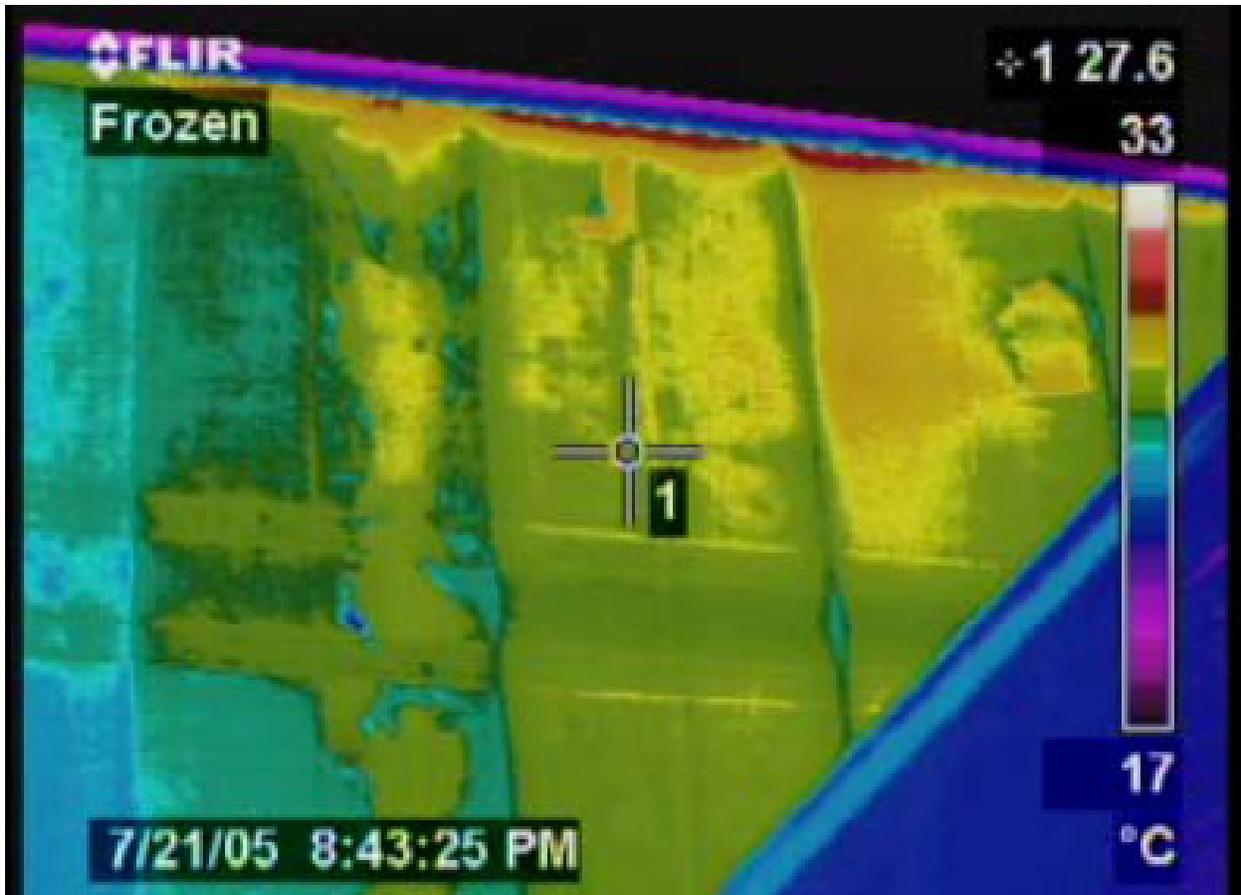
Figure 3

Figure 3, below, displays the thermogram produced by the south wall panels between a series of loading dock truck portal doors. The panels display elevated temperatures in areas that range in color from light green to yellow, yellow-brown, and red-brown. In the displayed wall areas, the warmest wall areas are directly below the roof gutter/roof flashing line and trend vertically downward from the roof line. As in Figure 1, the warmest areas are indicative of the areas with the highest moisture content.

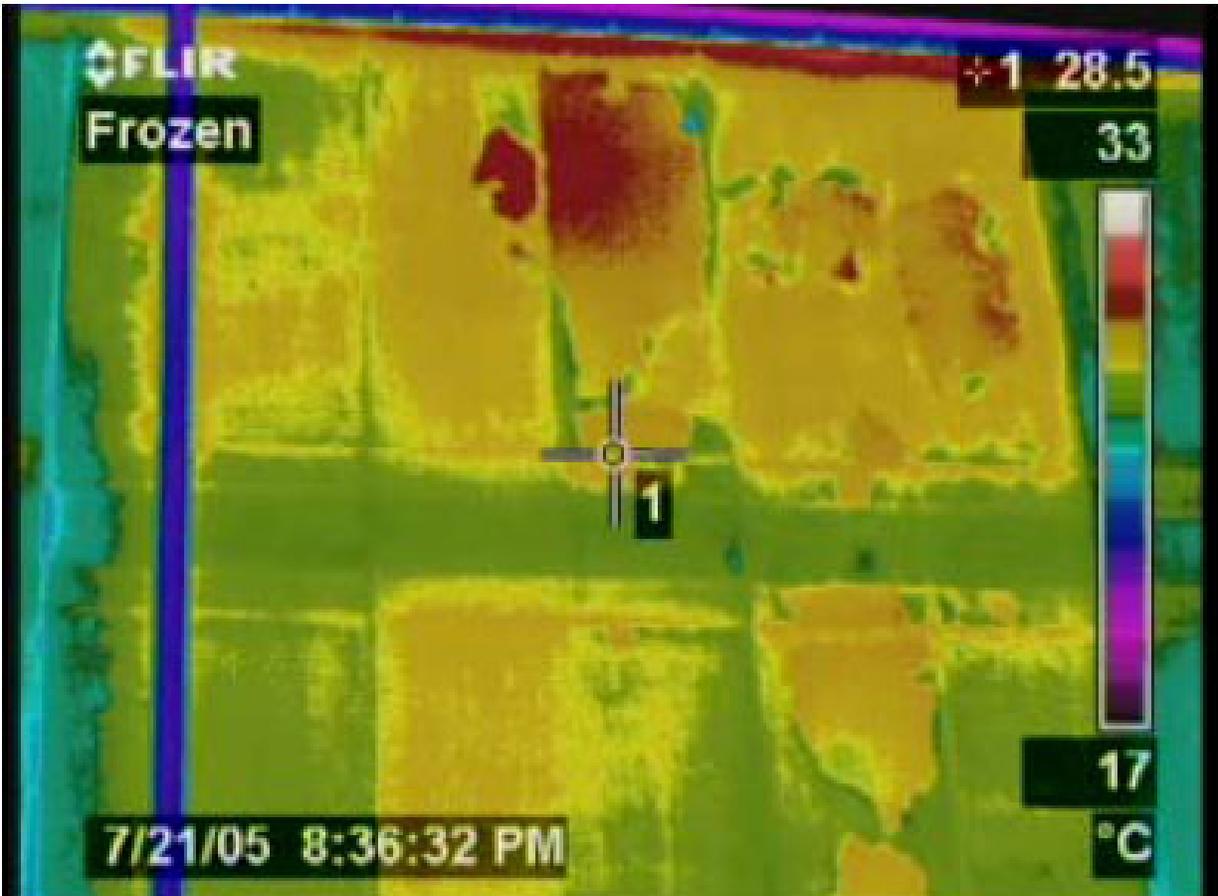
The following Figure 4 displays the thermogram produced by the south wall panels above and to the left of another truck portal door. The panels display elevated temperatures in areas that range in color from light green to yellow, yellow-brown, and red-brown. In the displayed wall areas, the warmest wall areas are directly below the roof gutter/roof flashing line that trend vertically downward from the roofline and concentrate in the panel area at the center of the thermogram. There is a significantly warm (red-brown) area that is at the upper portion of the center panel. Additionally, there is an extended warm area in the panel areas below the horizontal bond beam. As in the preceding thermograms, the warmest areas are indicative of the panel areas with the highest moisture content.
